PHOTOLUMINESCENT EXIT SIGNS NOT COMMERCIALY VIABLE

LIGHT TECHNICAL BRIEF

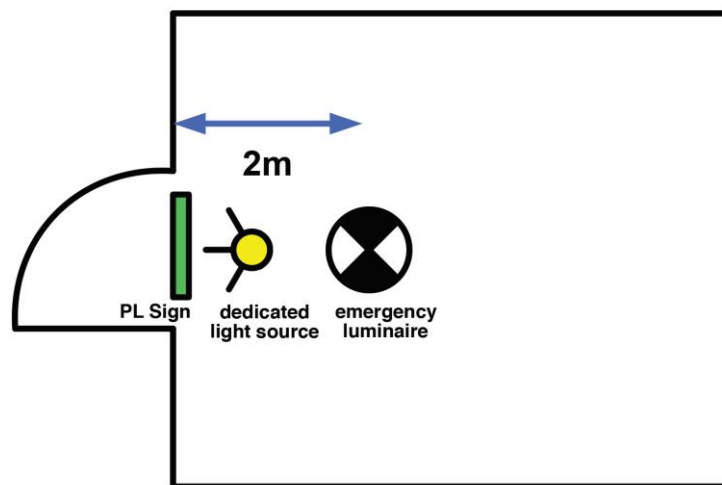
Emergency luminaire within 2m of the EXIT door

Photoluminescent EXIT sign

Dedicated light source with a colour temperature not less than 4000 K - to maintain the photoluminescent sign in a continuously charged state by a minimum illumination of 100 lux at the face of the sign

The use of a PL exit sign requires the installation of two additional lights:

1. A PL exit sign must have a dedicated, uninterrupted light source continuously illuminating 100 lux onto the face of the sign.
2. The NCC requires an emergency luminaire must be installed within 2m of an exit door or typically where exit signs are located.

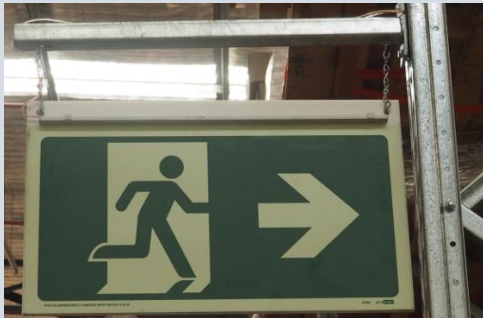
Strip lighting has failed making the sign non-compliant

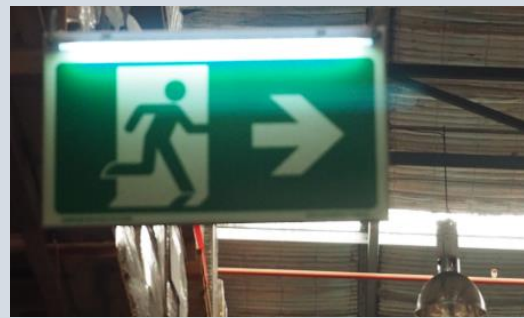
Strip lighting doesn't illuminate whole surface with 100 lux

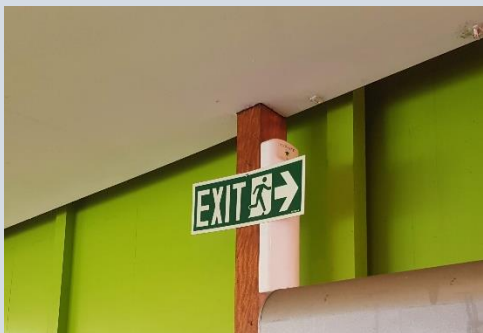
An installation without a dedicated light source and the required emergency light

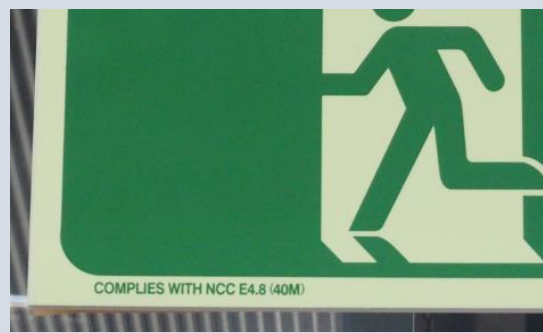
Rated distance of 40 m is non-compliant to AS/NZS 2293.1 (maximum 24 m)

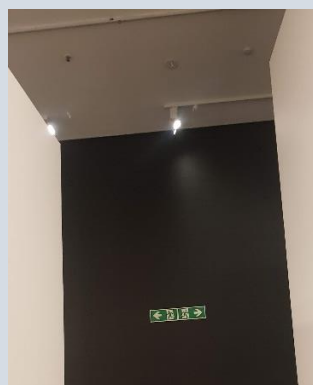
Track lights may be moved from their original positioning, making systems non-compliant
